# SEISMIC ASSESSMENT AND INNOVATIVE STRENGTHENING OF CORRODED CANTILEVER STRUCTURES IN MULTI-STOREY BUILDINGS

Notably, in the summer of 2022, a cantilever failure occurred in an existing building in Cyprus due to steel reinforcement corrosion. The current investigation considered this failure as a case study and employed a combined approach involving both destructive and non-destructive methods to characterize the mechanical properties of concrete and steel. By utilizing a structural analysis program and conducting nonlinear analysis, the structural integrity of the building was assessed and identified the critical structural elements. Furthermore, the reasons behind the cantilever failure, with a specific focus on exploring modern retrofitting techniques for reinforced concrete cantilever members were examined. These techniques include

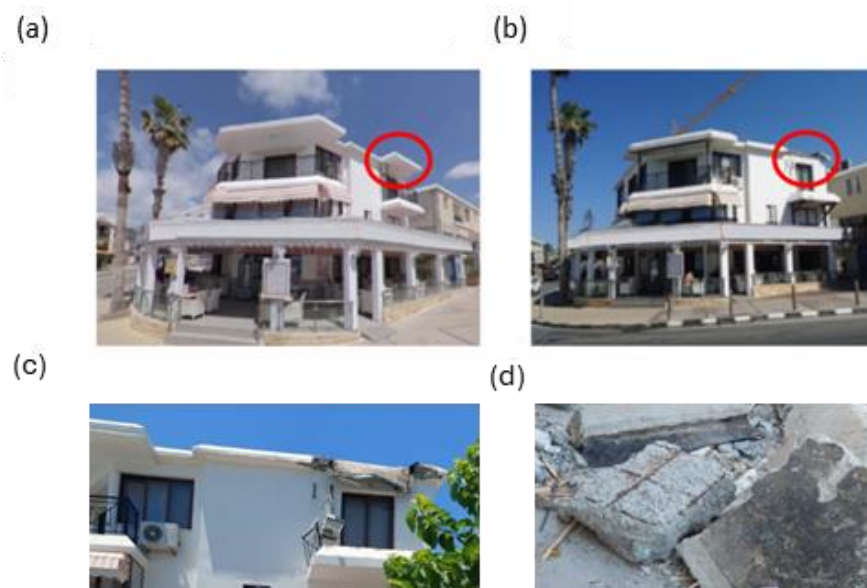
In July 2022, the cantilever (balcony) of the top floor of the above-mentioned structure, as depicted in **Figure 1 (a), (b), (c), and (d)**, failed under its own weight, resulting in its collapse. According to the structural analysis conducted in 1982, reinforcement of  $\Phi 10/27.5$  has been installed. The construction details of the steel reinforcement configuration during that period are shown in Figure 6. Following the aforementioned incident, the building was deemed temporarily unsuitable for occupation to undergo the necessary repair. A series of destructive and non-destructive tests were subsequently conducted to determine the mechanical properties of both concrete and steel reinforcement.

Figure 1: (a) Building facade (the failed cantilever is discernible) (Durable Structural Consulting Engineering Archive); (b) Building facade (the failed cantilever is visible) Durable Structural Consulting Engineering Archive); (c) and (d) Photographic documentation of the failure of the 165 cm cantilever (Durable Structural Consulting Engineering Archive).

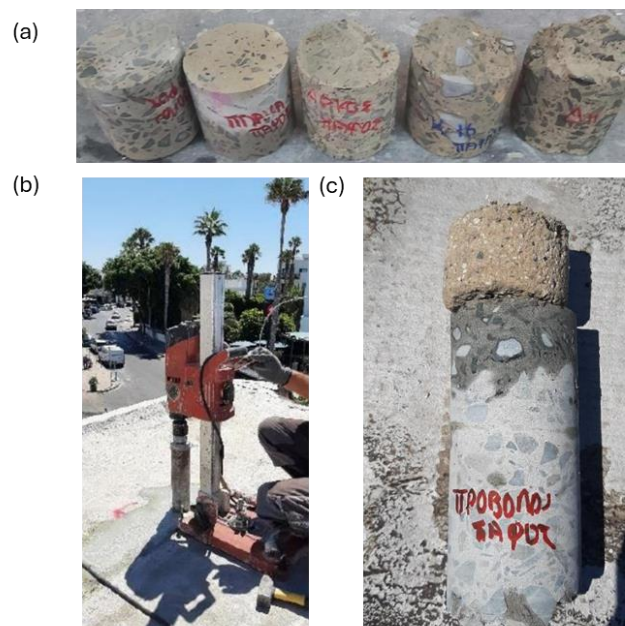
This was performed through undisturbed drilling and extraction of cylindrical concrete specimens using a coring apparatus. The extraction, preparation, and breaking of the cylindrical specimens were conducted according to the standard EN1254-1, (1971) [20]. A total of 5 specimens were extracted, aiming to obtain a representative sample. Subsequently, laboratory testing was carried out in a certified laboratory, involving the determination of compressive strength, carbonation depth, mass and weight of concrete, modulus of elasticity, and Poisson's ratio. The calculation of the in-situ characteristic compressive strength was performed according to the standard EN 13791, (2019) [21]. The sampling procedure and results are demonstrated in Figure (a), (b), (c), Table 1 and Table 2 respectively.

Figure 3: (a) Concrete core sample; (b) Extraction of core sample and (c) Cantilever's core sample (Durable Engine Structural Engineering LLC Archive).

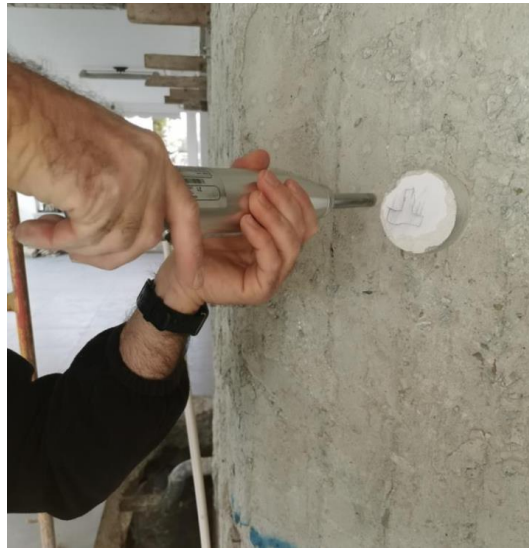
A total of 5 strikes were conducted on columns and beams of the examined building. The rebounds of the impact hammer on the surface of the concrete were measured (as illustrated in Figure 4), and the average of the measurements was taken to estimate the surface strength of the concrete. The procedure was carried out according to the standard CYS EN 12504-2, (2021) [24]. The results according to the above-mentioned procedure are demonstrated in Table 3.

Figure 4: Non-destructive testing of concrete employing Schmidt Hammer.
